Comments on Lower Colorado River Authority Fayette Power Project Draft Report

Assessment of Dam Safety of Coal Combustion Surface Impoundments

Sam Seymour - Fayette Power Project Station

Draft Report

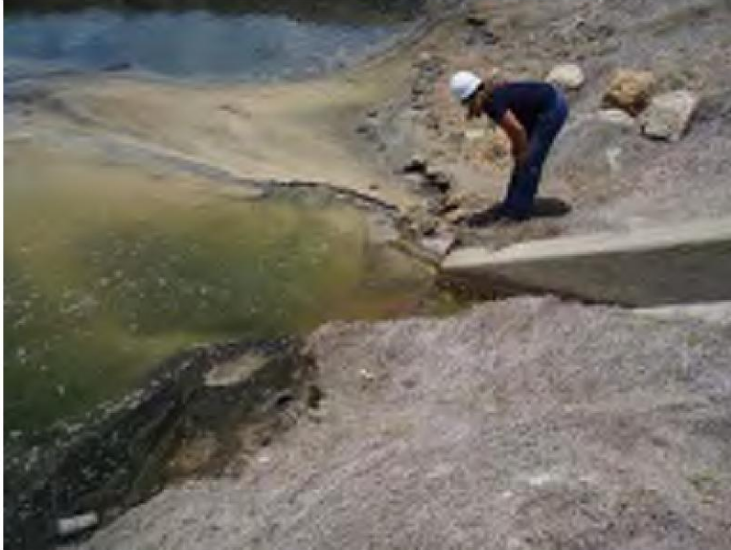
The waste drain trench (Photo 1) on the north embankment that drains into the impoundment was clear of debris and the channel was in good condition. The culvert headwall on the west embankment that discharges into the impoundment appears to

Photo No. 1: Reclaim Pond – Overview of waste drain trench outlet at the north embankment interior slope.

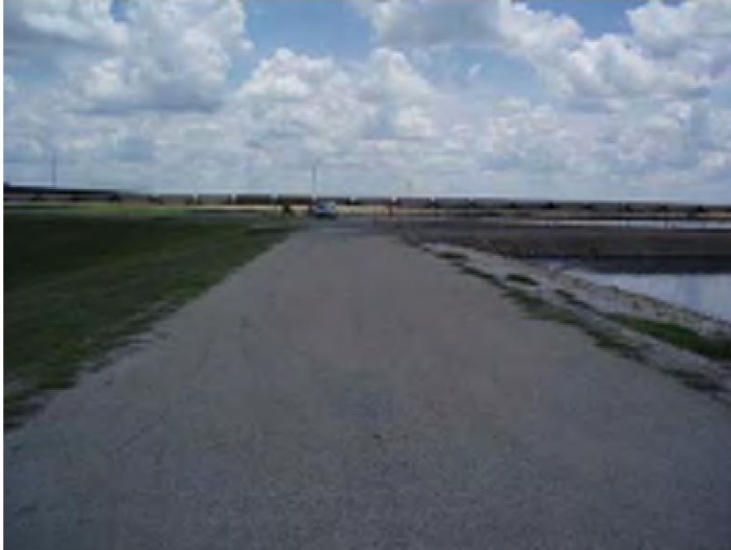
Photo No. 3: Reclaim Pond – North embankment crest, looking east

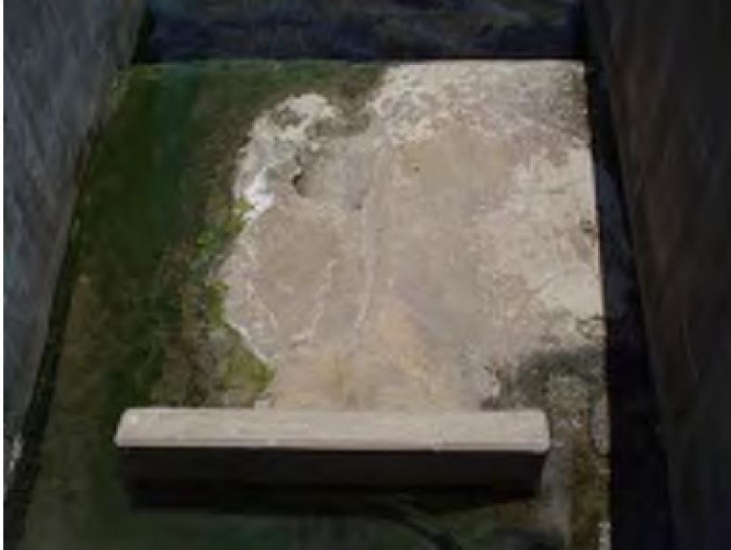
Photo No. 9: Reclaim Pond – Overview of stormwater outlet structure on west embankment interior slope. Stormwater is from FGD residue silos and truck wash area.

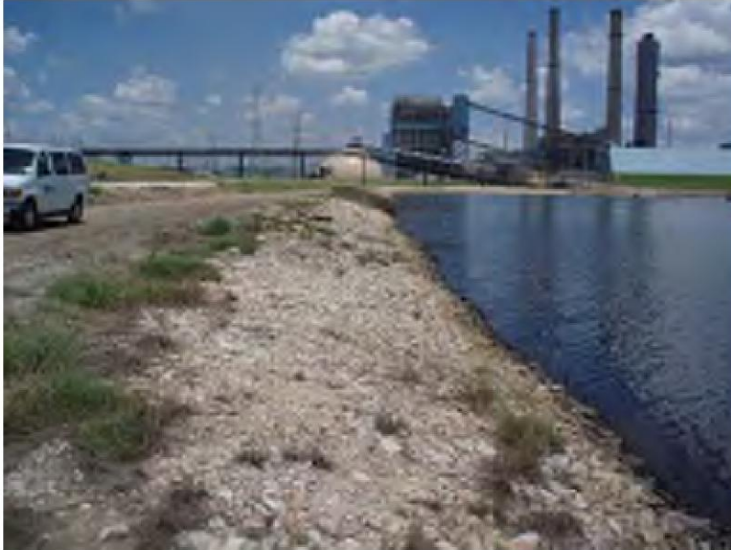
Photo No. 11: Reclaim Pond – West embankment interior slope, looking north.

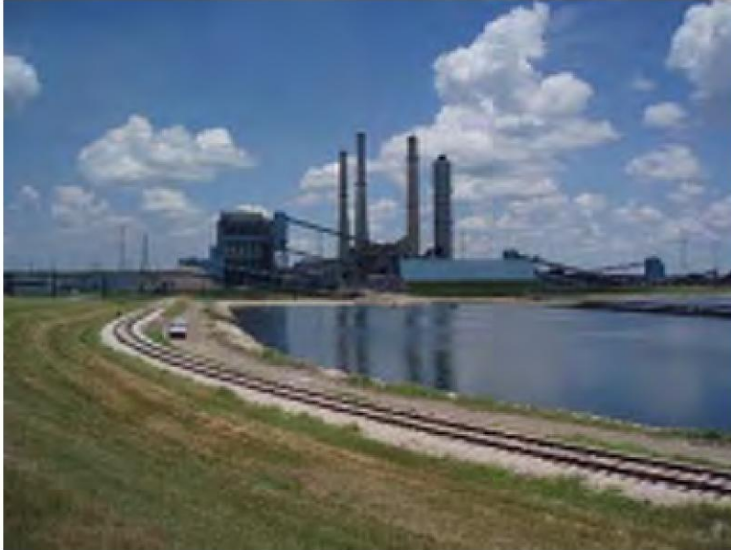
Photo No. 13: Reclaim Pond – Overview of western portion of impoundment, looking north.

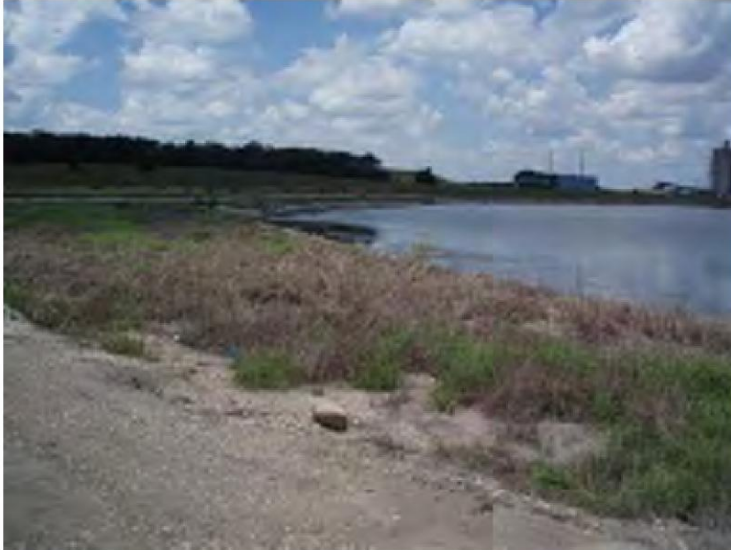
Photo No. 17: Reclaim Pond – Overview of south embankment, looking northwest.

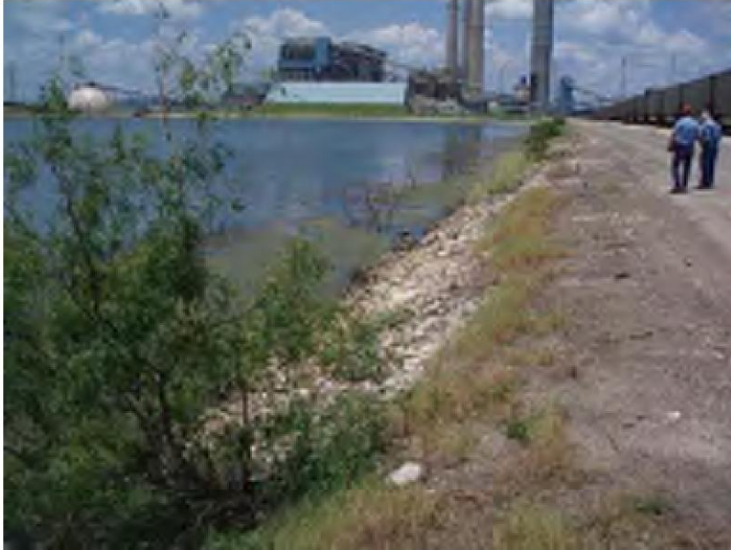
Photo No. 19: Reclaim Pond – East embankment interior slope, looking at a 4-inch-diameter

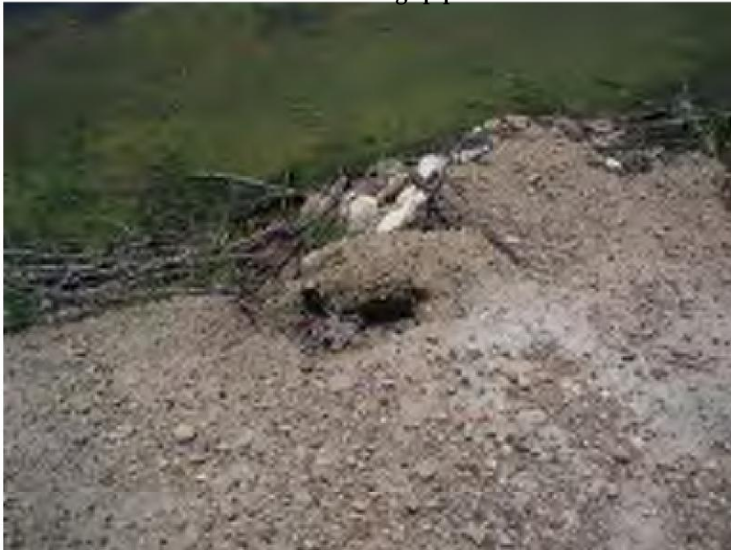
On the east embankment, there was one 2.5-foot-wide erosion rill (Photo 22). There was also an area where an abandoned 12-inch-diameter HDPE pipe from the CADP discharged into the Reclaim Pond. This area of the interior slope was eroded and some of the riprap was missing.

Photo No. 22: Reclaim Pond – East embankment interior slope, looking at 2.5'W erosion rill.

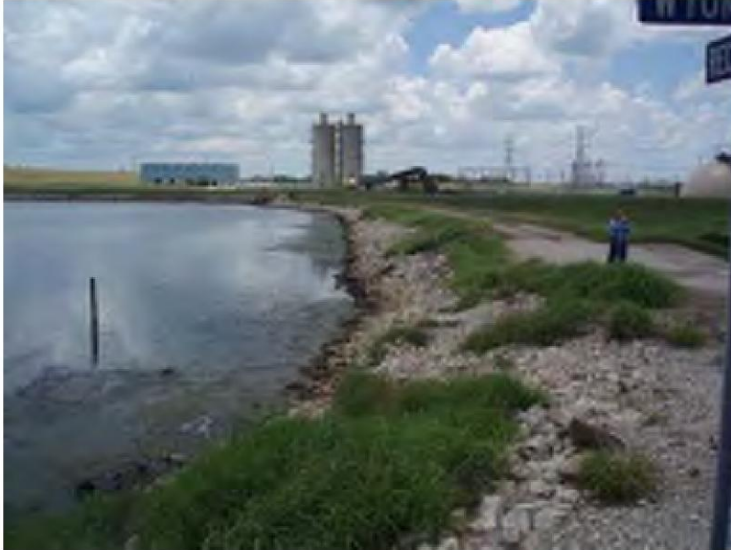
Photo No. 25: Reclaim Pond – North embankment interior slope, looking west.

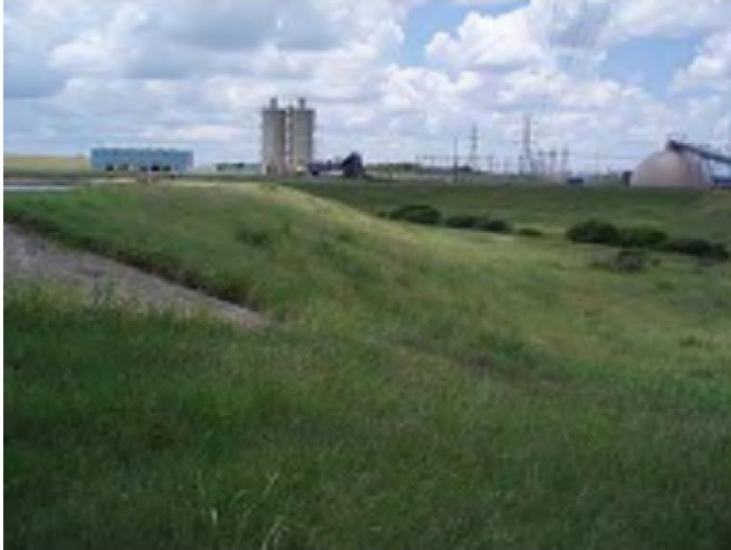
The exterior slope on the north appears to be in fair condition (Photos 2, 27, 34, 37, 38, 39, 40, 41, and 42). The grass on the north embankment ranged from 12 to 36 inches in height. Some minor brush and ~~huisache~~ ~~pricker~~ bushes were observed on the slope. Brush and trees were observed at the toe of the slope in the drainage ditch. Desiccation cracks up to a 1/2 inch wide and eight (8) inches deep were observed at various locations on the embankment face.

Photo No. 27: Reclaim Pond – North embankment exterior slope, looking west.

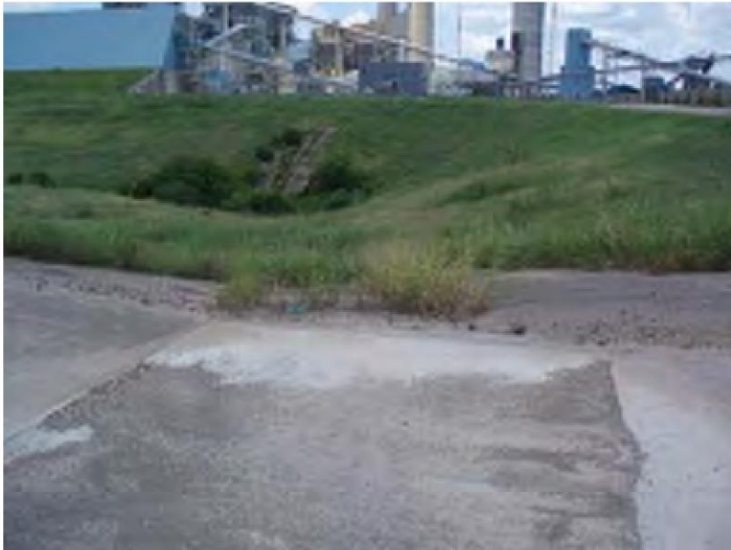
Photo No. 30: Reclaim Pond – North embankment, looking north at spillway discharge channel.

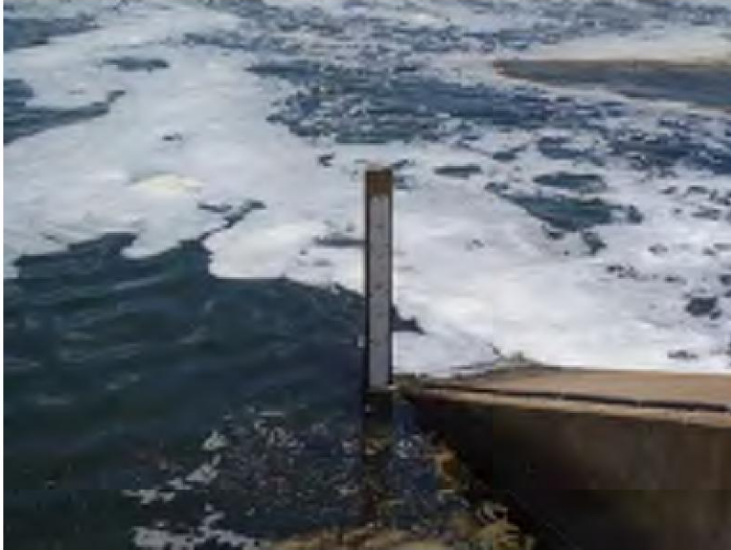
Photo No. 33: Reclaim Pond – North embankment interior slope, looking at staff gage at

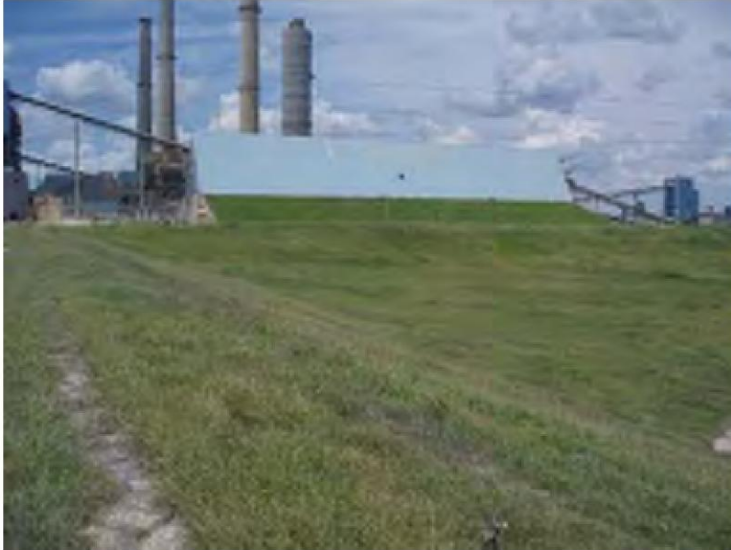
Photo No. 39: Reclaim Pond – Overview of north embankment downstream area, looking north.

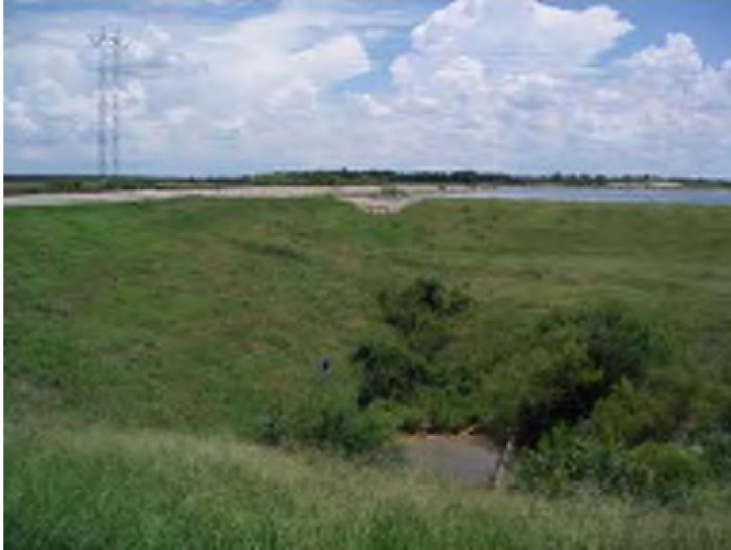
Photo No. 41: Reclaim Pond – Overview of north embankment spillway and railroad embankment, looking south. Note small trees growing at the toe in the drainage ditch.

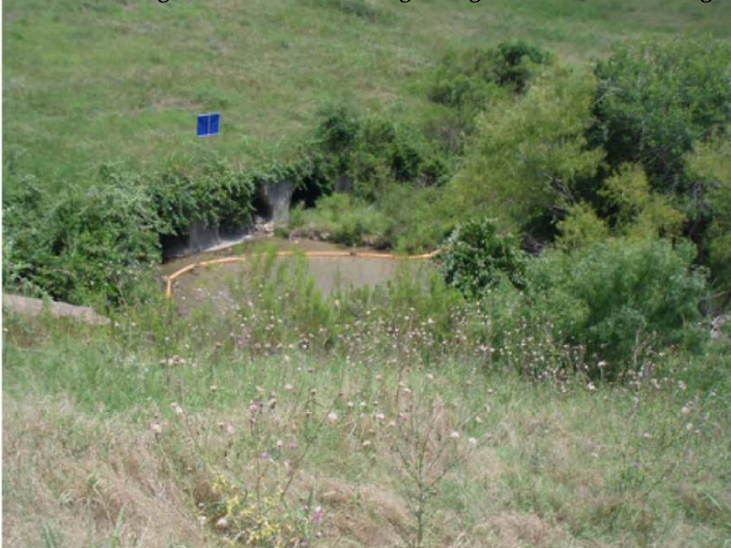
Photo No. 42: Reclaim Pond – Overview of triple arch culverts under railroad embankment. Note small trees and vegetation in the drainage ditch and debris in the arch culverts.

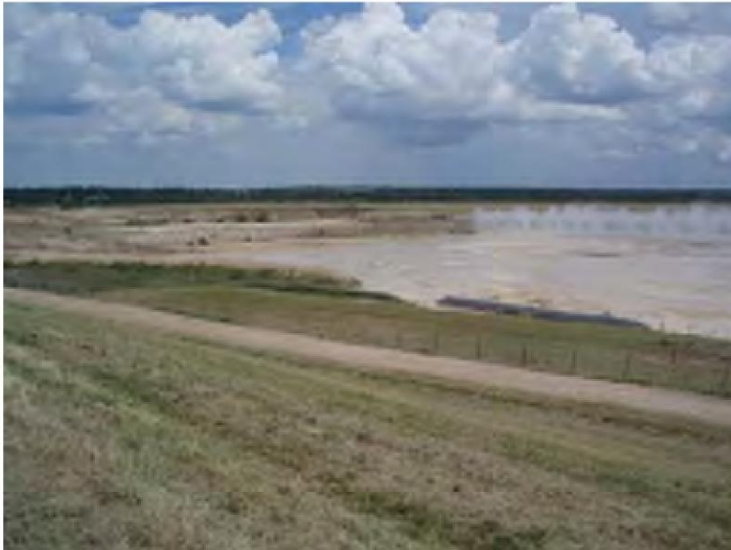
Photo No. 52: CADP – Overview of final settling basin, looking southeast. Note evaporation

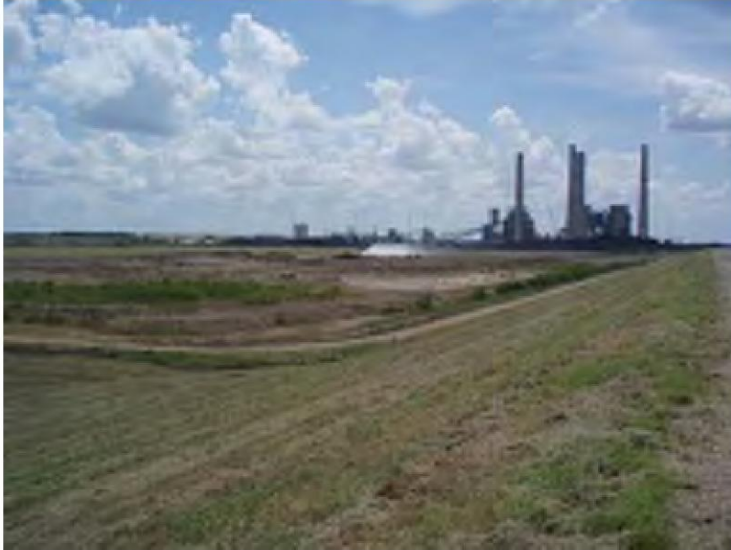
Photo No. 53: CADP - Overview of active portion of impoundment, looking southwest.

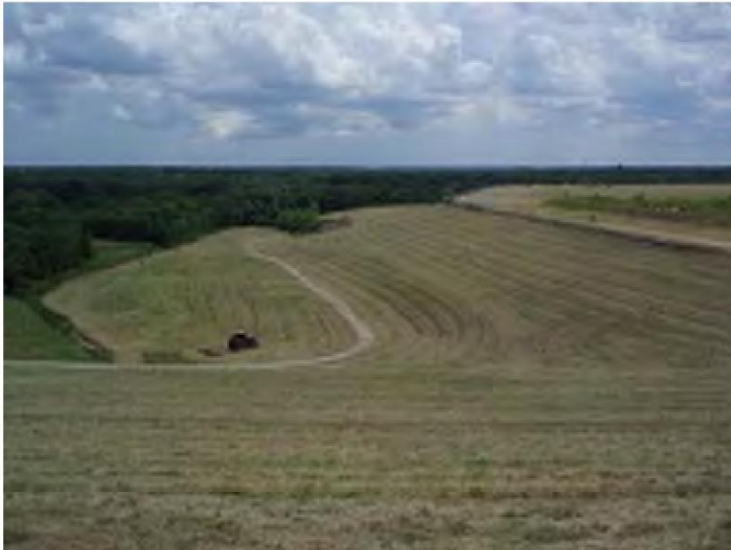
Photo No. 54: CADP - Overview of east embankment and downstream area, looking south.

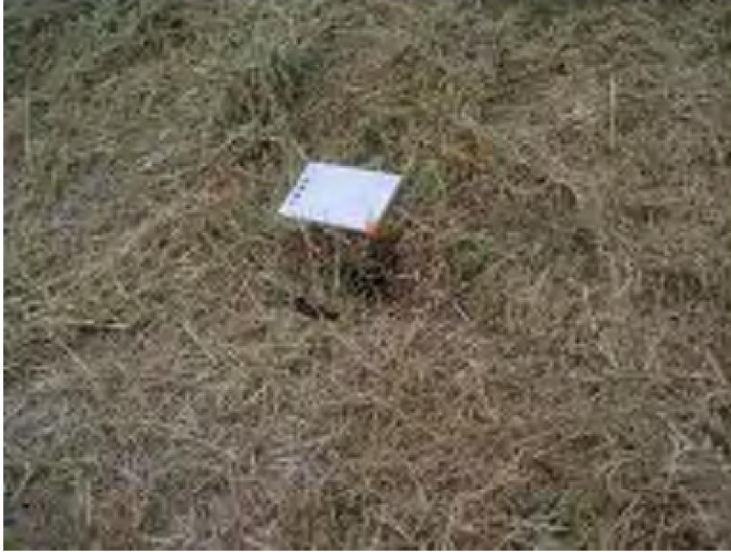
Photo No. 65: CADP – East embankment exterior slope, looking at an 8-inch-diameter rodent

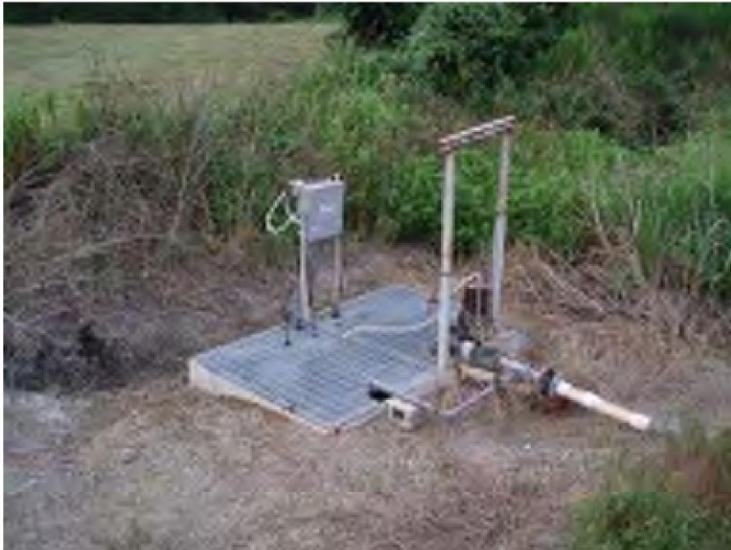
Two of the toe drain outlets from the chimney drain on the east embankment were observed (Photos 64 and 66). [The toe drain shown in Photo No. 66 also connects to a third toe drain \(not photographed\) that collects drainage from the portion of the](#)

Photo No. 66: CADP – East embankment exterior slope, looking at toe drain seepage collection sump pit. Seepage water from the toe drain is pumped back to the impoundment.

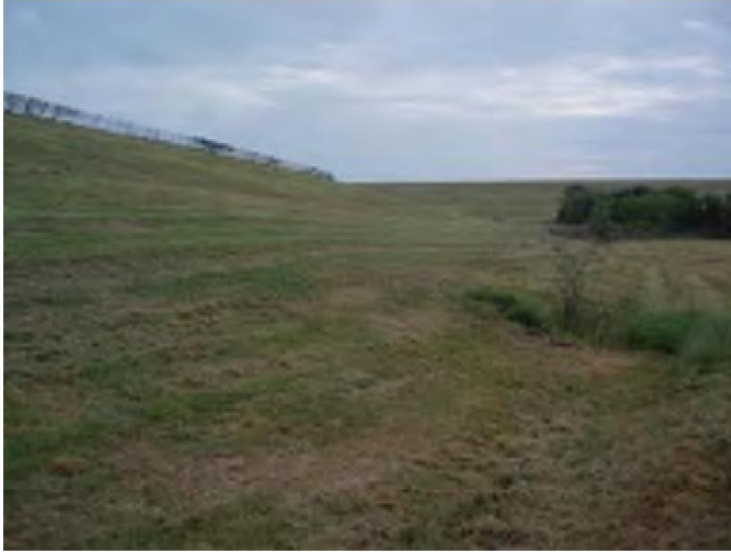
Photo No. 67: CADP - East embankment exterior slope, looking north.

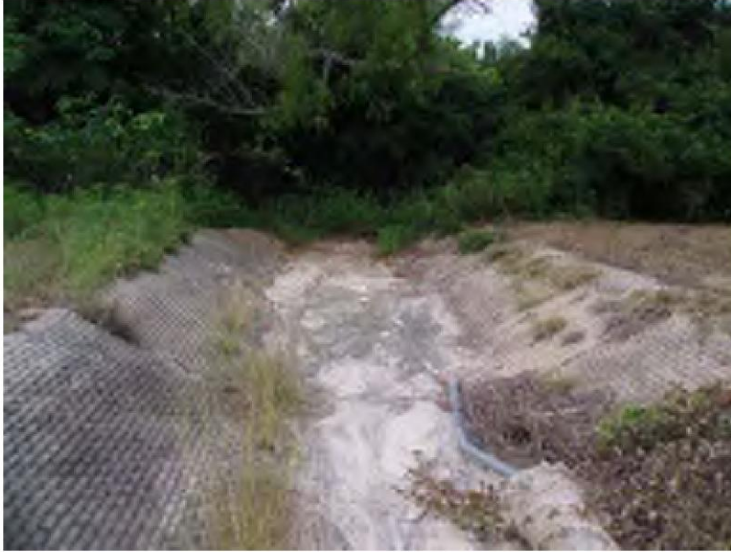
The CADP is incised on the north and west embankments. The south and east exterior slopes appear to be generally in fair condition (Photos 53, 54, 55, 57, 58, 60, 61, 62, 67, 68, 69, 71, 73, 74, 77, 78, and 85). The grass on the embankment was approximately 8 to 12 inches tall and was recently mowed. Trees and brush up to 6 inches in diameter were observed at the toe of the south embankment in the Coal Ash Pile Run-off Pond. There were some bare spots near the middle of the south embankment exterior slope (Photo 81).

Photo No. 69: CADP - East embankment exterior slope, looking south at stormwater discharge channel from capped portion of the impoundment.

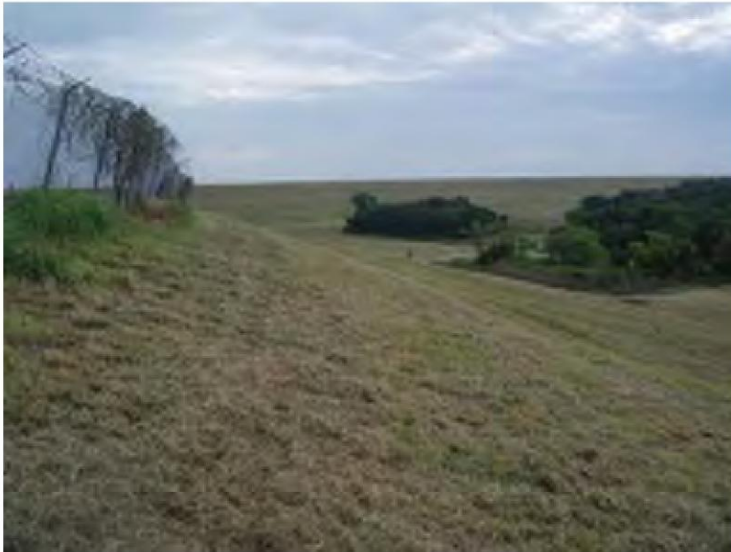
Photo No. 70: CADP - East embankment exterior slope, looking north.

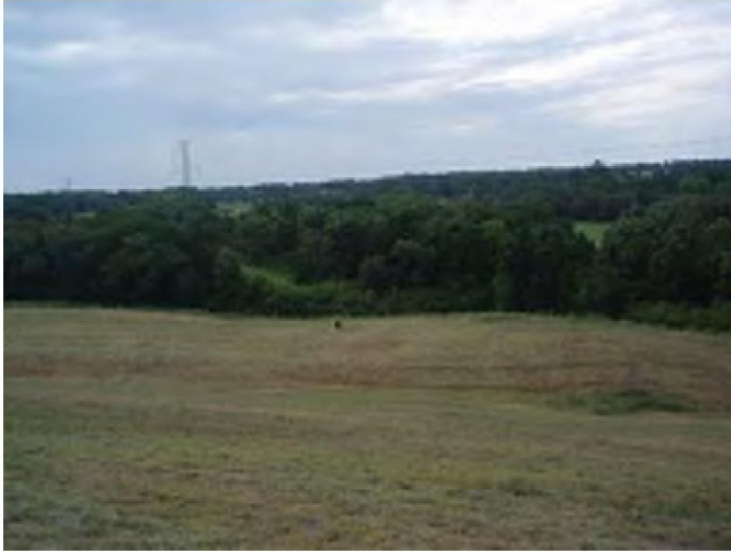
Photo No. 71: CADP – Overview of east embankment downstream area, looking east.

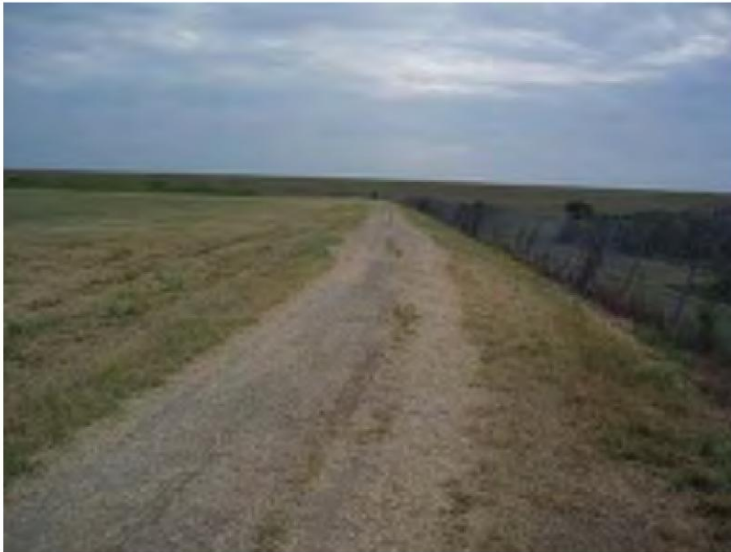
Photo No. 72: CADP – East embankment crest, looking north.

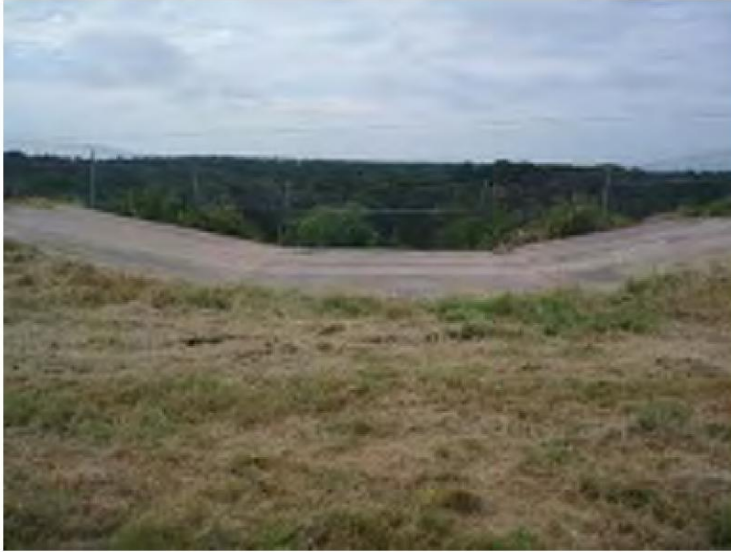
Photo No. 73: CADP - East embankment, looking south at approach to discharge channel inlet control section from capped portion of the impoundment.

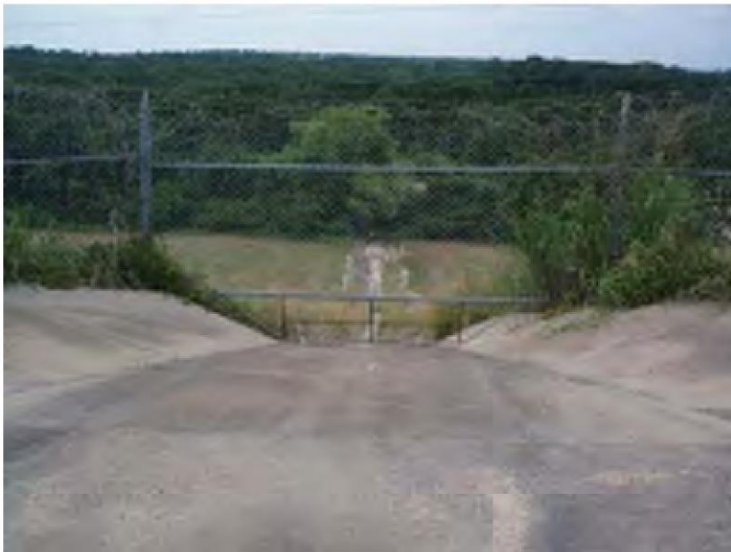
Photo No. 74: CADP - East embankment, looking south at stormwater control section outlet

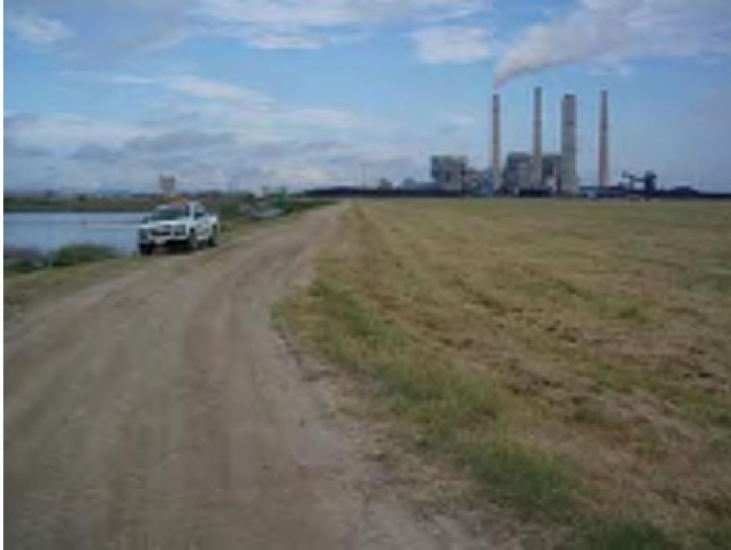
Photo No. 75: CADP - South embankment crest and capped area, looking west.

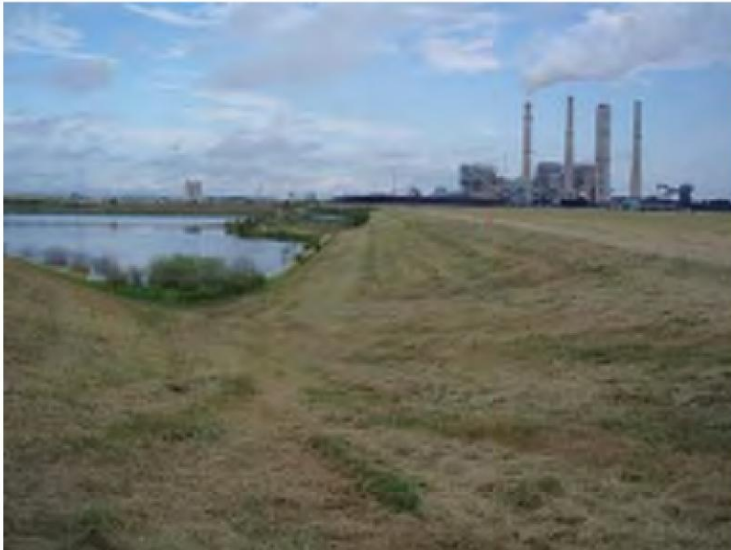
Comment [b13]: Photo 76 is a photo of the interior of the Coal Pile Run Off Pond and should be excluded from this paragraph

Photo No. 76: CADP - Groin of south embankment exterior slope and Coal Pile Run-off Pond interior slope, looking west. Note water, brush and small trees at toe of slope.

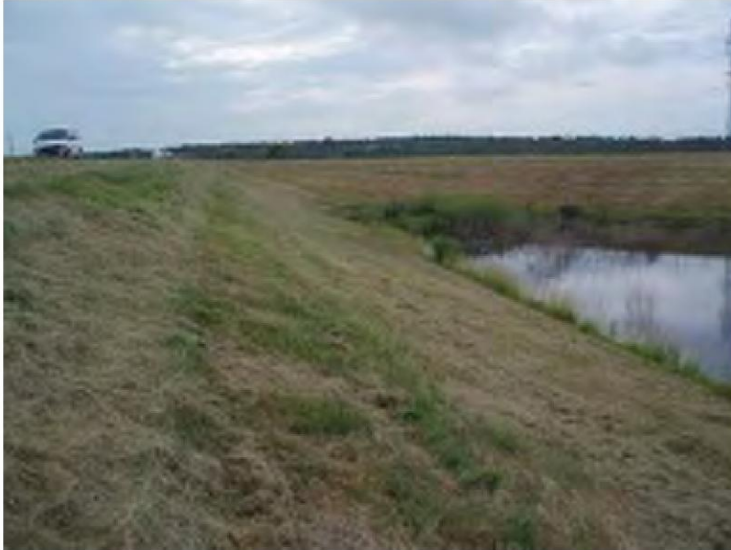
Photo No. 77: CADP - South embankment exterior slope, looking east at groin with Coal Pile Run-off Pond. Note water, brush and small trees at toe of slope.

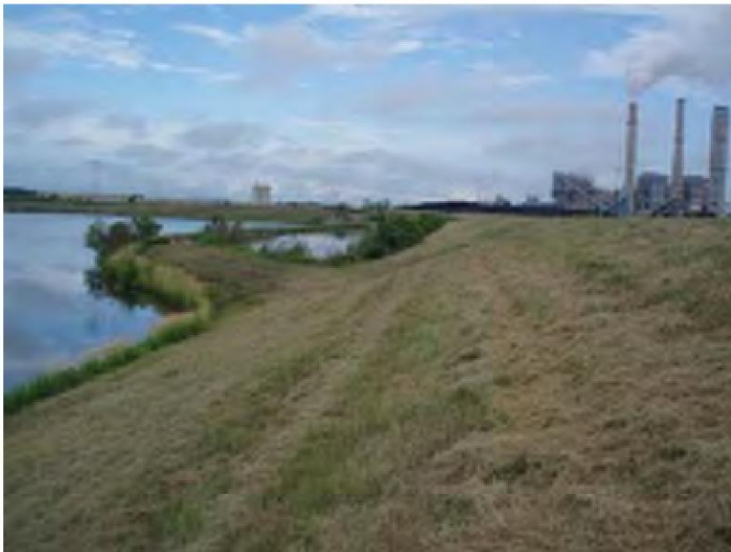
Photo No. 78: CADP - South embankment exterior slope, looking west.

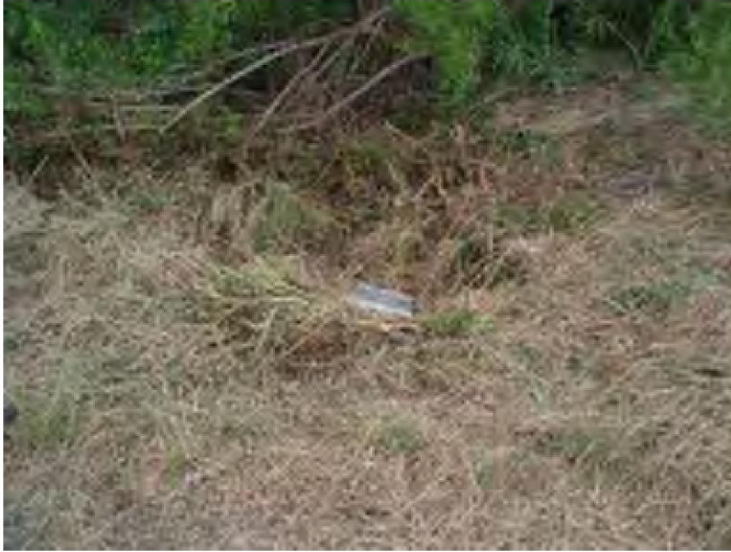
Photo No. 79: CACP – South embankment exterior slope, looking at 3'Wx4'Lx2'D depression at toe of slope. Possible collapsed rodent burrow

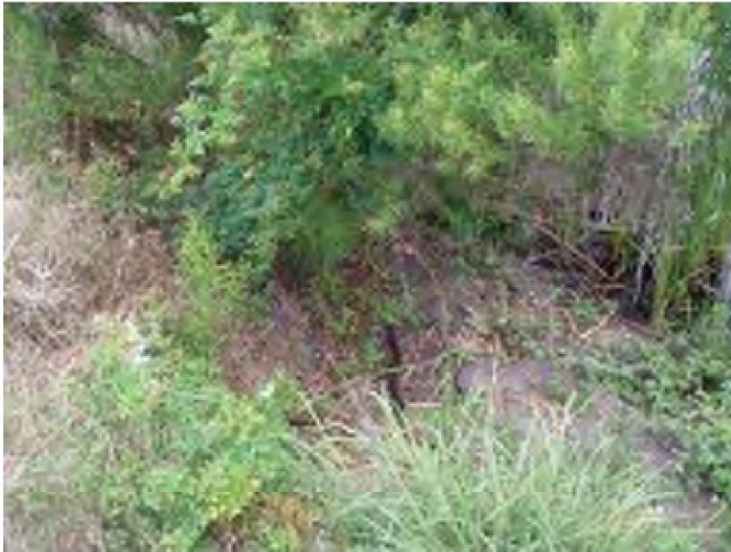
Photo No. 80: CACP – South embankment exterior slope, looking at 4'Wx5'Lx2'D depression at toe of slope. Possible collapsed rodent burrow.

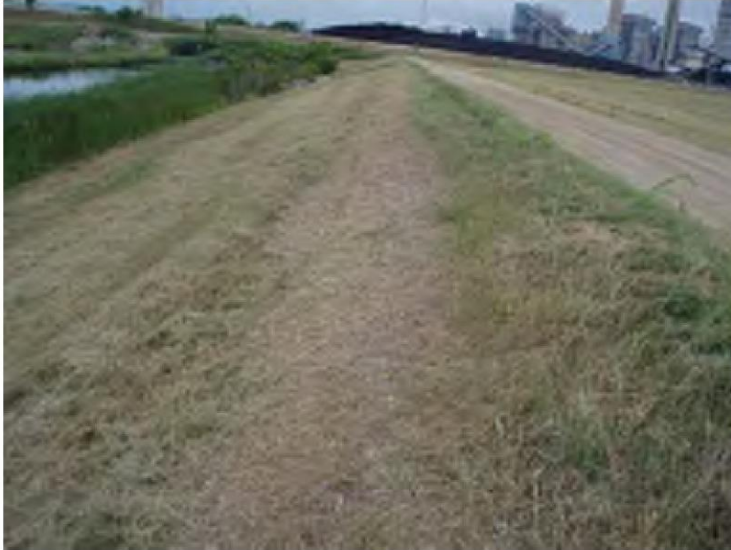
Photo No. 81: CADP - South embankment exterior slope, looking west. Note sparse vegetation near crest.

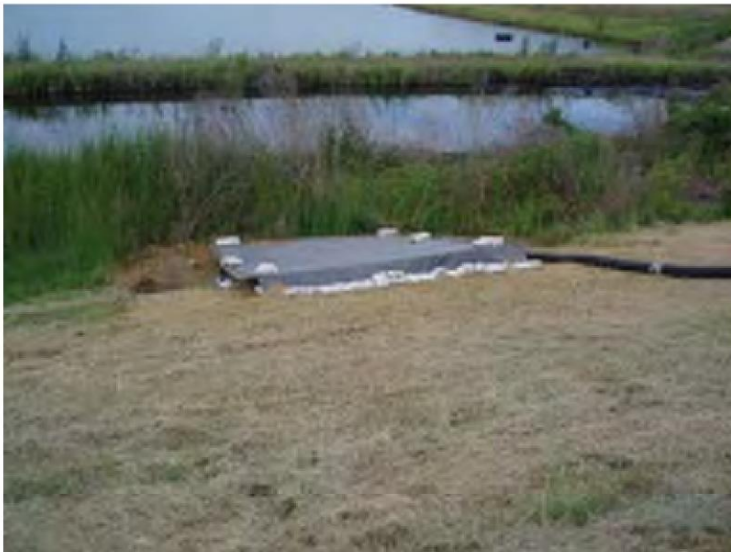
An active seep on the south embankment exterior slope was observed (Photos 82 and 83). LCRA has constructed a containment structure to collect the seepage water. The estimated flow from the seep typically ranges from 8 to 11 gallons per day based on review of information provided by LCRA personnel.

Photo No. 82: CADP - South embankment exterior slope, looking at seep containment system.

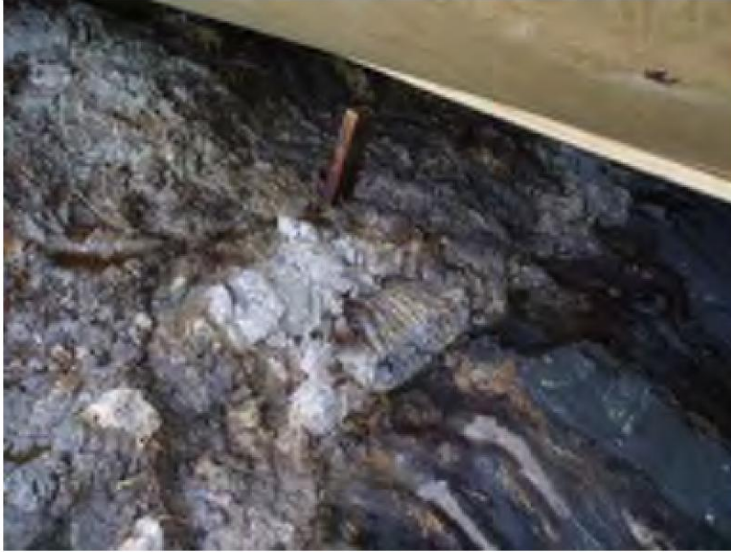
Photo No. 83: CADP - South embankment exterior slope, looking at seep. Note liner down slope of seep to collect water. Flow ~8 gallons per day.

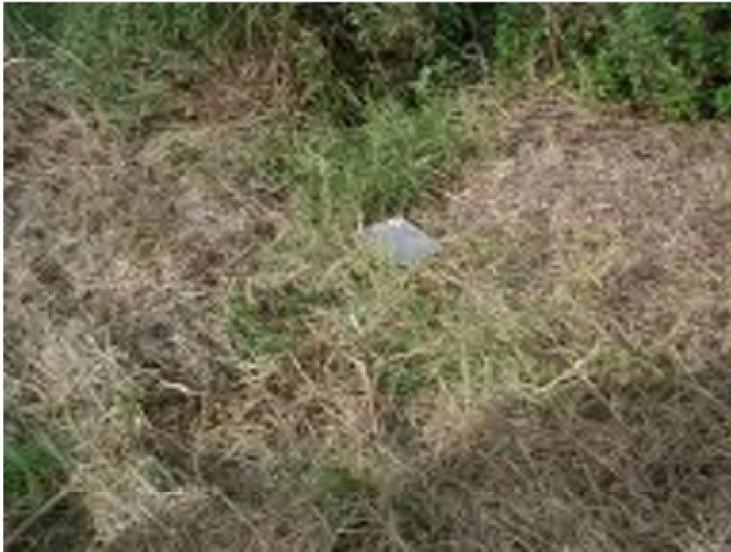
Photo No. 84: CADP - South embankment exterior slope, looking at 2'Wx4'Lx1'D depression at toe of slope. Possible collapsed rodent burrow.

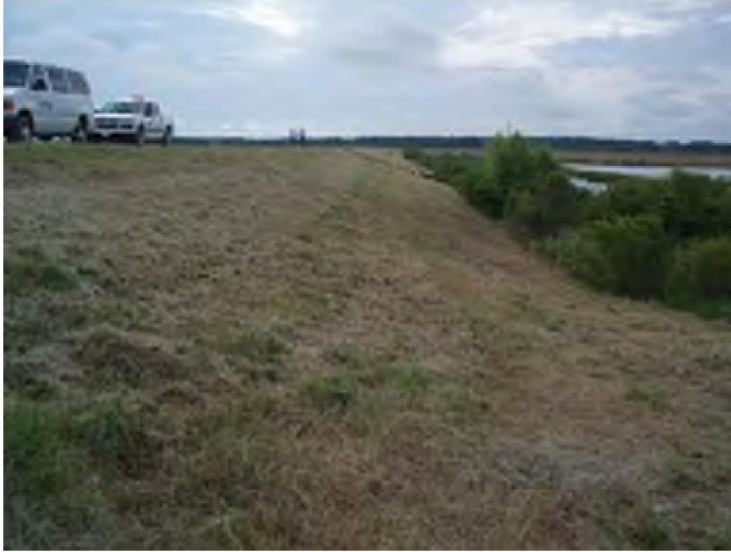
Photo No. 85: CADP - South embankment exterior slope, looking east.

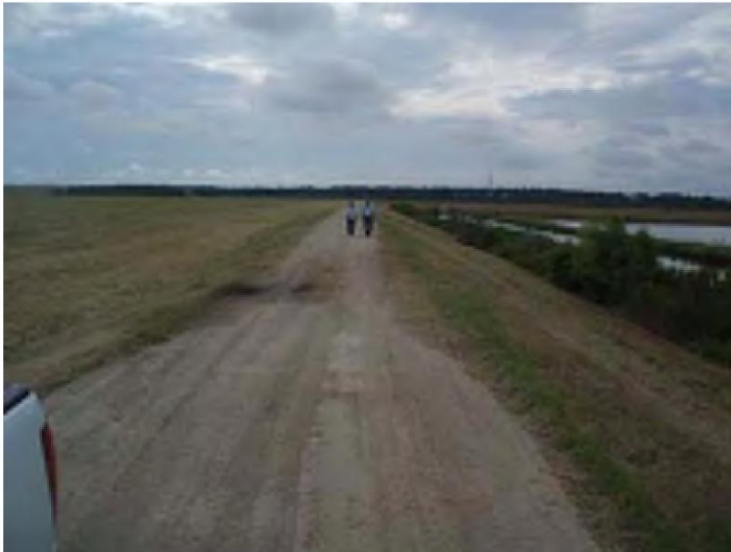
Photo No. 86: CADP - South embankment crest, looking east.

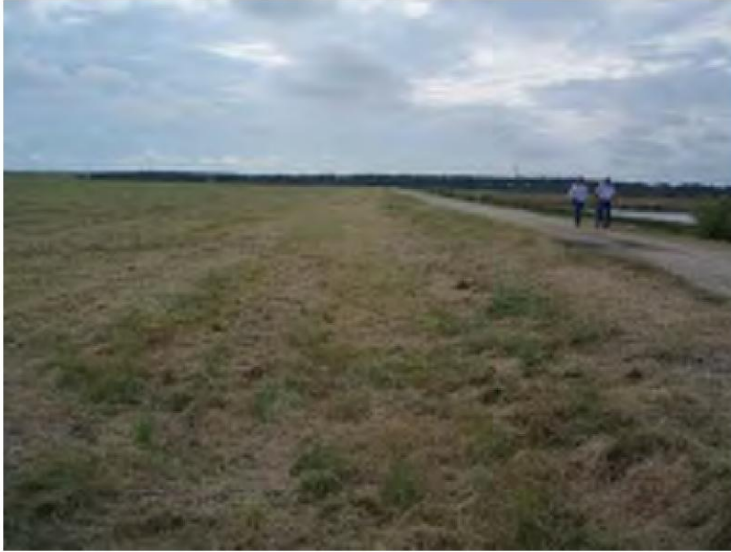
Photo No. 87: CADP - South embankment, looking east at capped portion of impoundment.

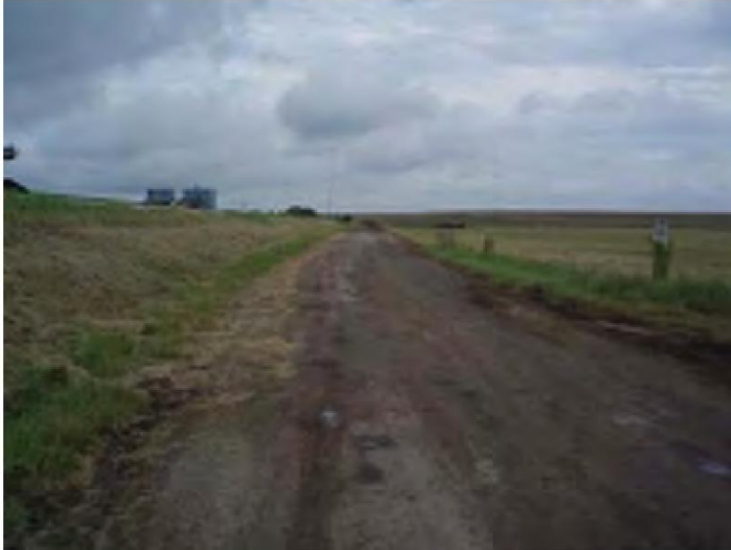
Photo No. 89: CADP – West embankment crest, looking north.

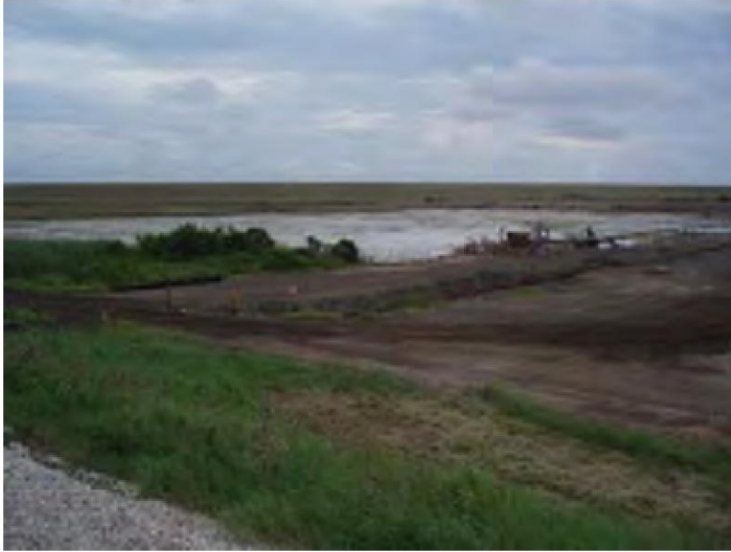
Photo No. 91: CADP - Overview of the active portion of the impoundment, looking

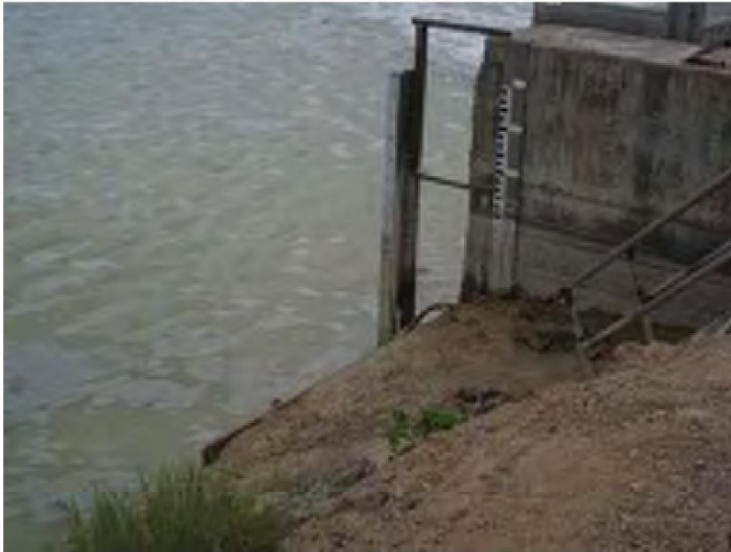
On the northwest corner of the intake structure there are two manual staff gauges in the CADP (Photos 92 and 93). The pond water levels are recorded twice a day and

Photo No. 92: CADP - West embankment interior slope, looking at staff gage on intake structure.

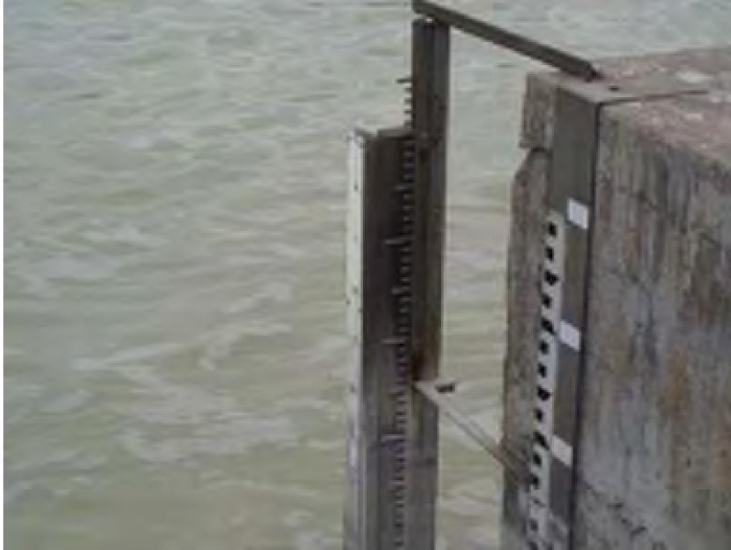
Photo No. 93: CADP - West embankment interior slope, close up of staff gage on intake structure.

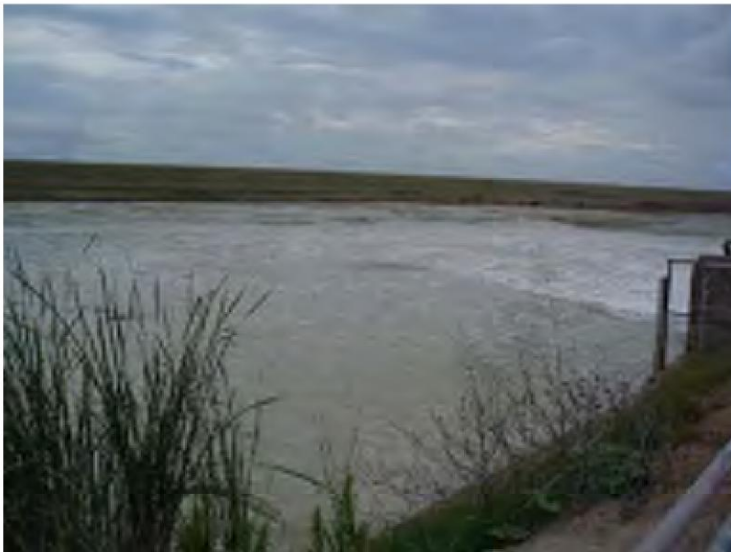
Photo No. 94: CADP - Overview of final settling basin area, looking

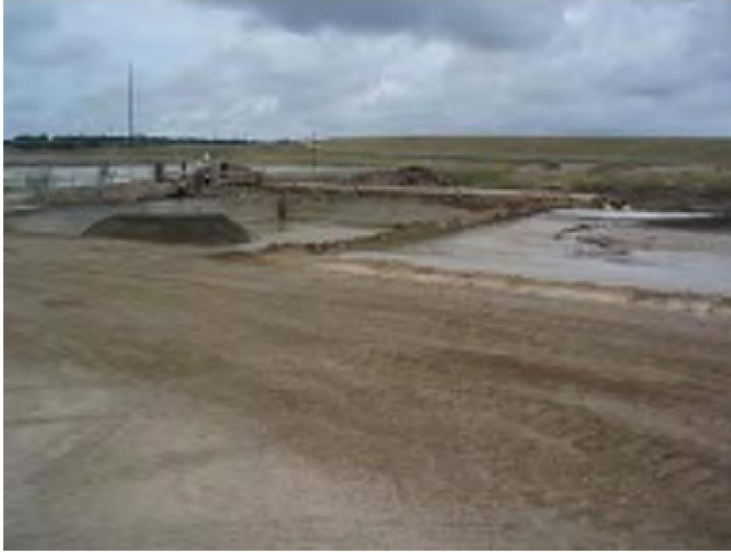
Photo No. 95: CADP – Overview of two primary settling basins where CCW is sluiced into the impoundment. Settling basins are alternated and cleaned out when full.

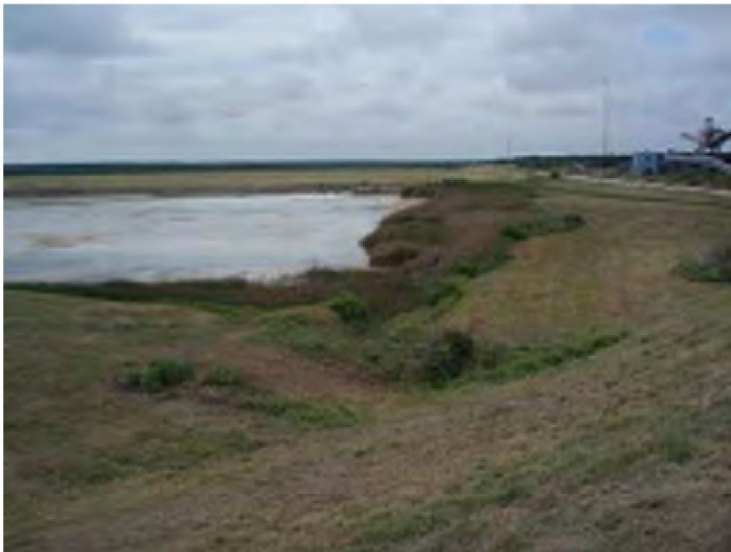
Photo No. 96: CADP – West embankment interior slope, looking south.

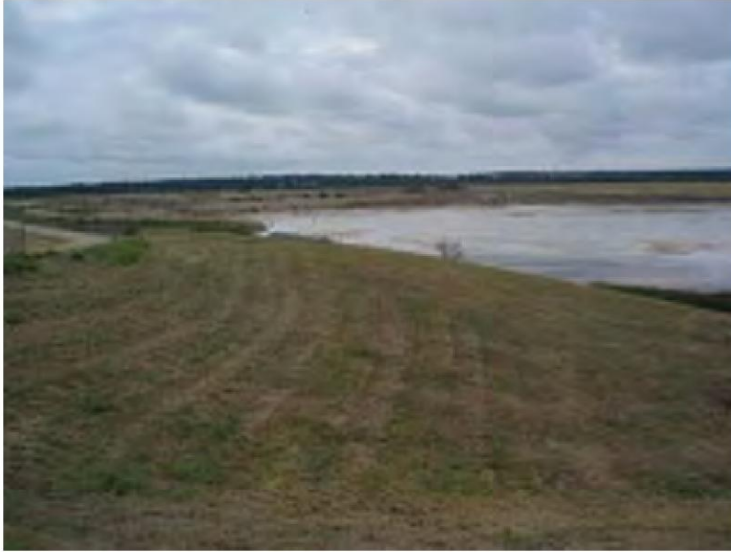
Photo No. 97: CADP - Overview of active portion of impoundment, looking southeast.

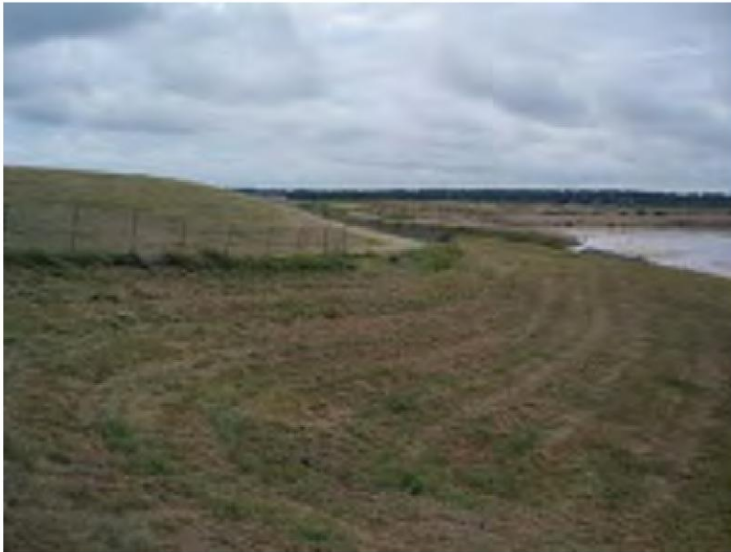
Photo No. 98: CADP - North embankment interior slope, looking east. Note Cedar Creek Dam on left side of photo.

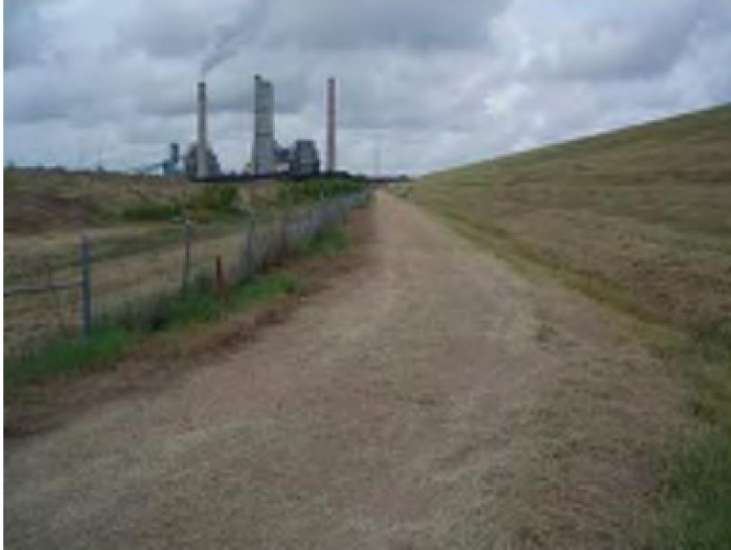
Photo No. 101: CADP - North embankment crest, looking west.

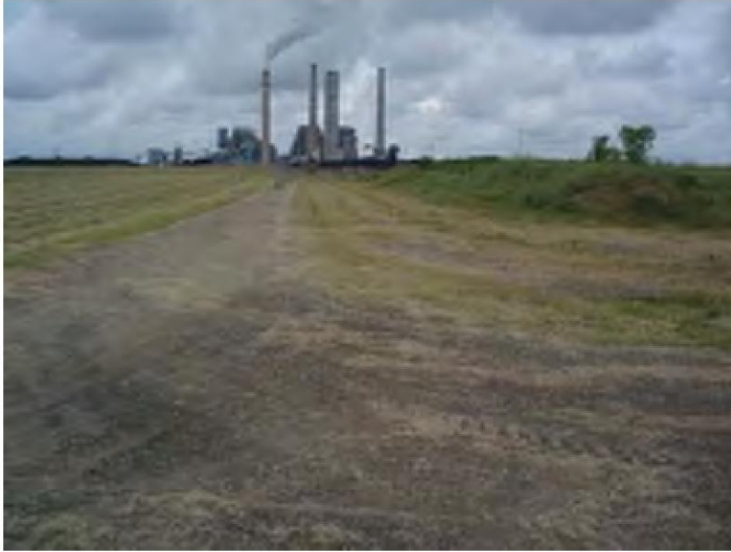
Photo No. 103: CADP – Looking west at transition from active portion to capped portion of impoundment from east embankment crest.

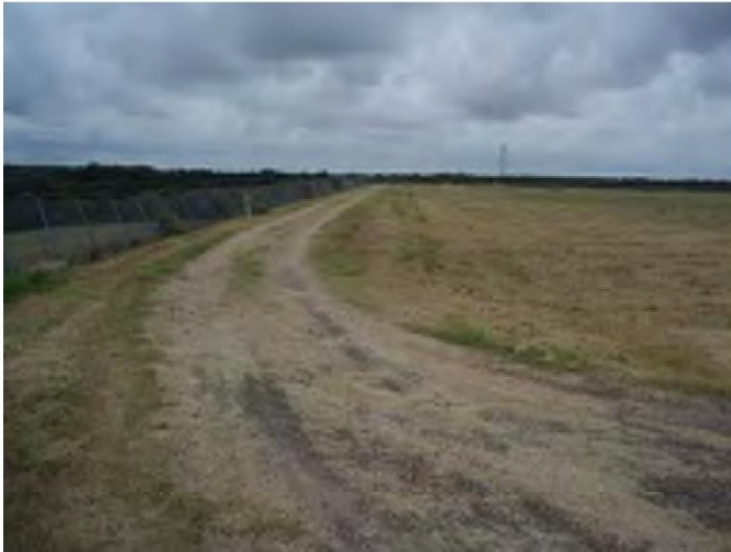
Photo No. 104: CADP – East embankment crest, looking south.
